Fracture failure analysis on drive shaft component of diesel locomotive

A Adiman^{1,*}, B Budiarto² and S Siswanto¹

Abstract. Failure analysis is a systematic method of investigation to find the cause of the failure mechanism of a component or equipment. This research describes the fracture analysis of driveshaft components in a diesel locomotive. The drive shaft which is a connecting component around the compressor in the locomotive engine has failed. The methods used in this study include literature studies, visual observations, data collection, material characteristics through chemical composition tests, hardness tests, tensile tests, microstructure observations, fractographic observation, data processing, and analysis of test results. Based on the results of chemical composition testing and mechanical testing shows that the drive shaft is classified as plain carbon steel, specifically AISI 1025 steel. Visual observations and microstructure observations show that the driveshaft failure occurred at the connection part, which is the connection around the welded region. From the fractography results show a visible pattern of deformation plastic that showing the fracture occurred

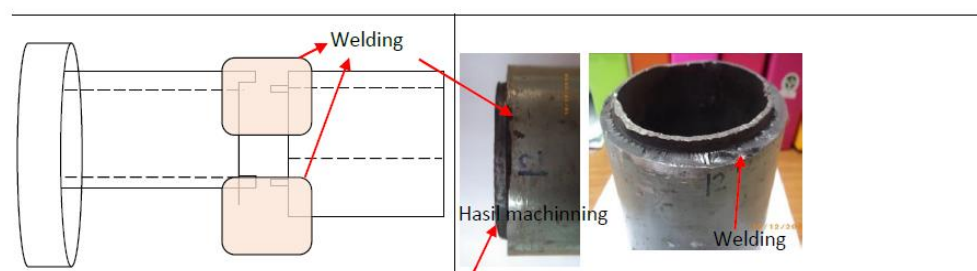
The results of visual observations indicate that the failure area is the result of the joining process by welding method, specifically by the existence of differences in the inner and outer surfaces. The joining process was carried out by machining the outside of one side and then welding as shown in Figure 2.

Figure 2. Illustration on the fracture area showing the fracture area is the result of joining welding.

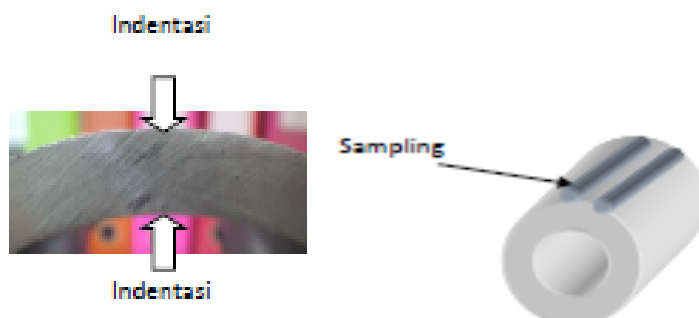
Hardness testing was done in accordance with ASTM standard E18 using the Rockwell B method. Hardness testing is carried out on the outside and inside of drive shaft for comparison. The results of testing shown in Table 2. The results hardness testing shows that there is no significant difference between deep and surface the outer surface of the drive shaft. The results also shows that the hardness of material in line to AISI 1025 standard.

Figure 3. Position of sample hardness testing.

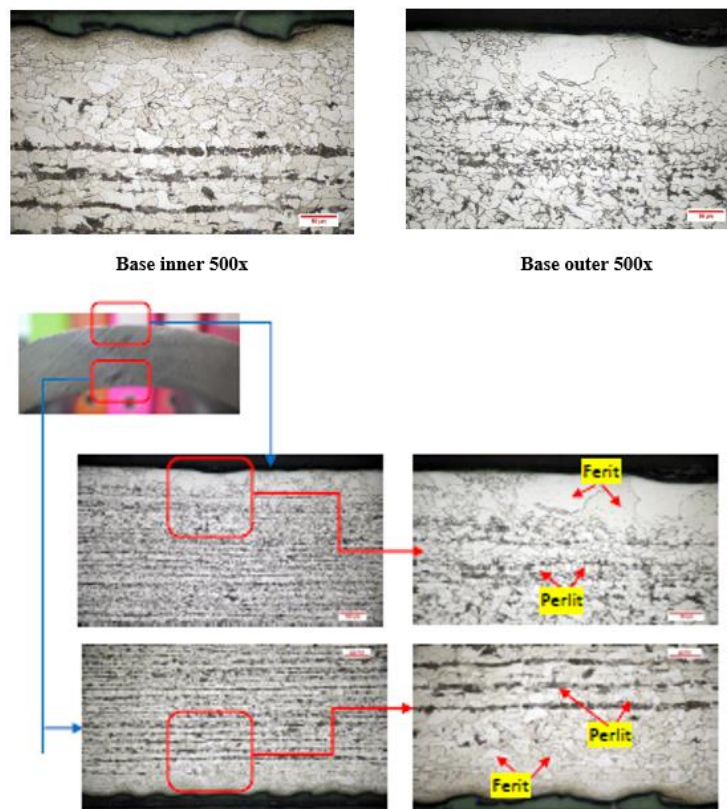
Microstructure observations was done of far areas from fracture and fracture area. On far area from fracture show that there is no difference microstructure on the top and parts below, the microstructure consists of ferrite-pearlite phases as shown in Figure 4. Pearlite phase is seen as an area black and elongated shape. The elongation shape is an effect of rolling process to get thickness which is desired. While the ferrite phase seen as a white area. Based on test results chemical composition, drive shaft material classified as low carbon steel should have a majority of ferrite phases. Microstructure observations shows that the ferrite phase is more dominant compared to the pearlite phase, its so confirm the results of chemistry composition testing (OES).

Figure 4. Microstructure on the far area from fracture.

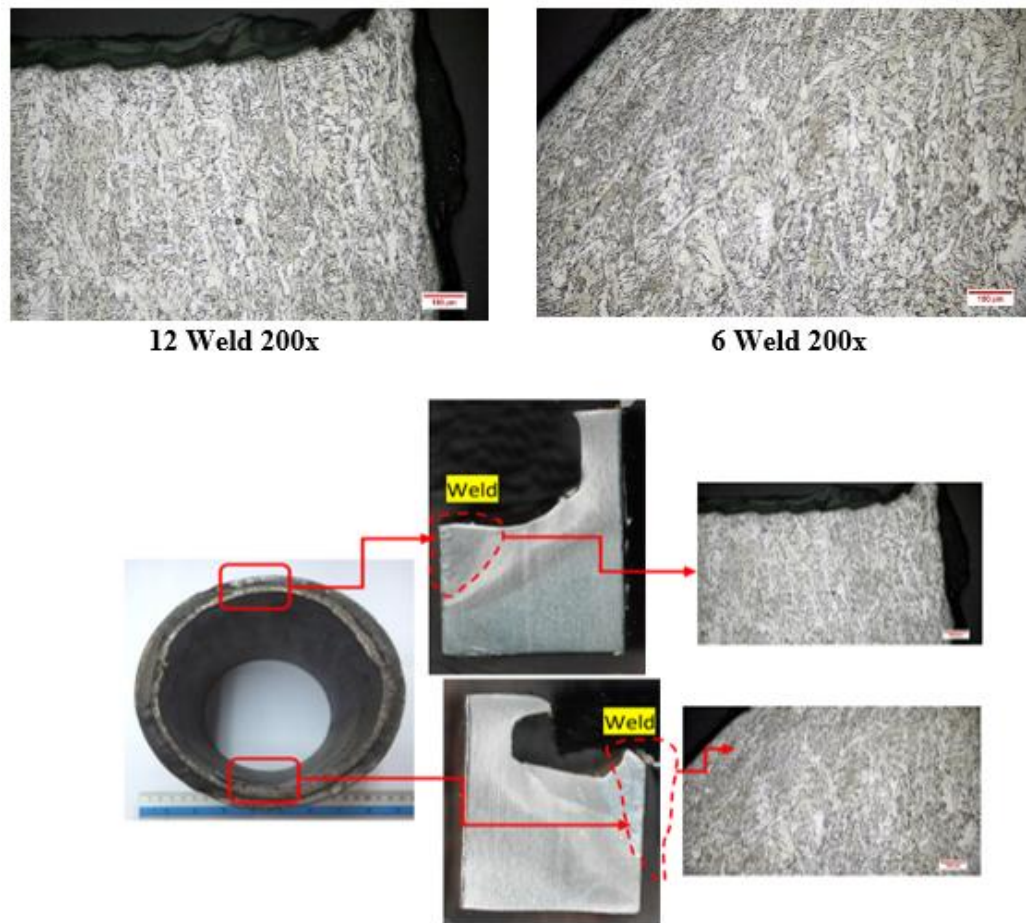
The Observation of microstructure was done in the fracture area. The sampling position is in the 12 and 6 o'clock areas with transverse image taking directions. The results can be seen in Figure 4.4. The results of the microstructure observation re confirm that the fracture area is a welding joint, that is seen from the differences in grain size and the presence of weld metal. Microstructure observations also show that fracture on metal welds indicate that weld metal cannot withstand the load given.

Figure 5. Microstructure on the fracture area.

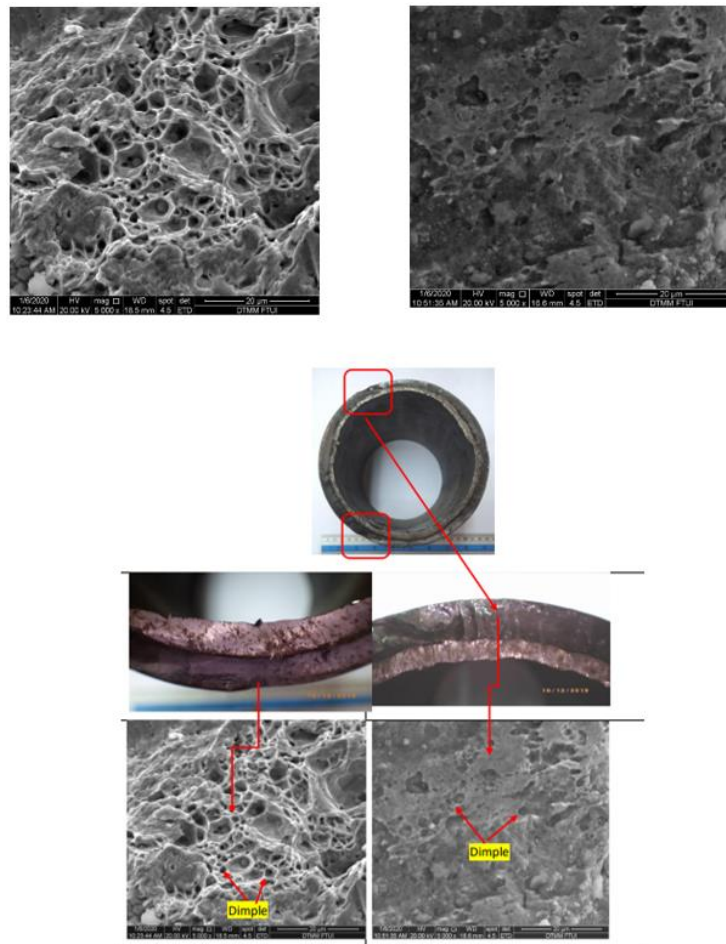
Microstructure observation was done in the fracture area. The sampling position is at 12 and 6 o'clock areas using SEM that the results can be seen in Figure 4.5. The results of Observation on fracture surface shows that plastic deformation occurs characterized by the presence of structure dimple. Dimple is a combination microvoid at the time of plastic deformation. On elastic deformation, the distance between metal atoms can still stretch and return to original position if the load released, but at the time of deformation plastic, metal atoms cannot return to original position and at the time back load is increased then it will microvoid formed due to no metal can compensate for the increase volume due to strain formed. The presence of dimple on the fracture surface shows that welding joints cannot withstand the load given so that deformation occurs and finally broke up.

Figure 5. Fractography on the fracture area using SEM.
