## Structural Assessment of Rental Housing Flat Lere in Palu Affected by Palu Earthquake on September 28, 2018

**Abstract.** Rental Housing flat Lere in Palu, Central Sulawesi is one of rental housing flats built by Directorate General Cipta Karya, Department Public Works and Housing in cooperation with local government of Palu during fiscal year of 2010-2011. It is one of buildings damaged by Palu earthquake. To assess the severity of building damage induced by earthquake, building structural engineering experts were conducting engineering investigation. Data from field investigation were used to develop computer model employed in simulating damage mechanism. By running structural model, one can explain damage mechanism in building during the earthquake. From this study, the building is considered severely damage and need to be destroyed. To rebuilt in the area, it is necessary to use structural system that highly resistance against vertical earthquake and to use updated building design codes.

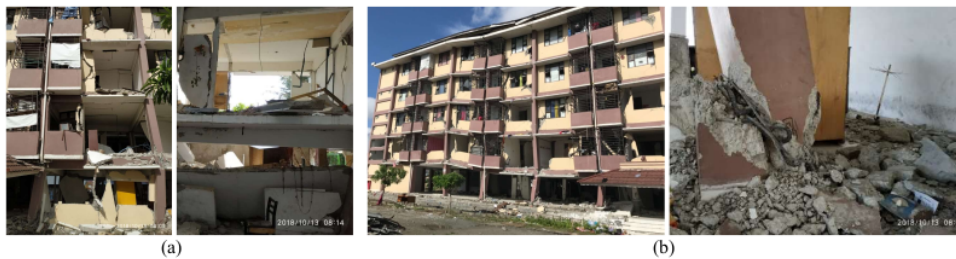
Survey of building condition assessment post-earthquake taken place on September 28, 2018 at rental low-cost housing flat Lere in Palu conducted on October 13, 2018. Based on visual observation and analysis show that this housing flat suffered major damage in both structure and architectural components as can be seen in Figure 1.a and 1.b, respectively.

**FIGURE 1.** Pictures of damaged rental low-cost housing flat Lere: (a) major architectural damage, (b) major structural damage concentrated on base columns undergone compression failure and combined shear and tensile failure

Based on the detailed evaluation conducted in this study, the building is determined to be unreparable and thus needs to be destroyed. If the building is to be rebuilt, it is better to be relocated, built using high performance earthquake resistance structural system that is able to resist vertical earthquake and use recent design building codes.

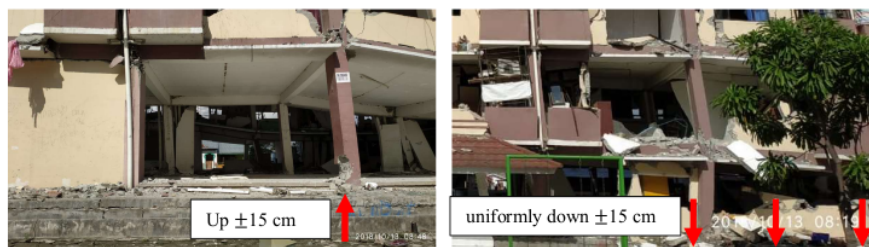
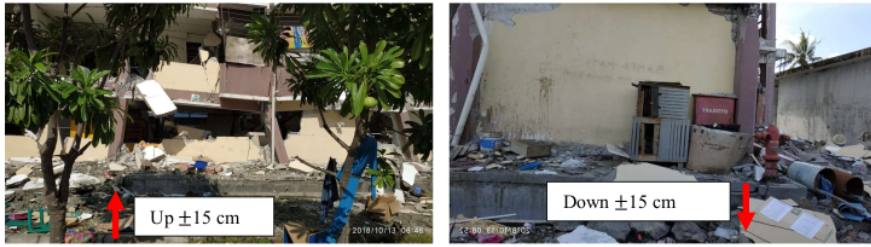
Failure mechanism of structure occurred at rental low-cost housing flat Lere was triggered by vertical earthquake load that was dominant load in this earthquake. The wave of vertical load led to significant soil deformation and thus caused one point of structure deforming down and the other point up (forming wave-like vertical deformation along length of building). This failure mechanism can be described using Figure 2.

FIGURE 2. Soil deformation pattern due to vertical earthquake (pictures continuous along the length of building)

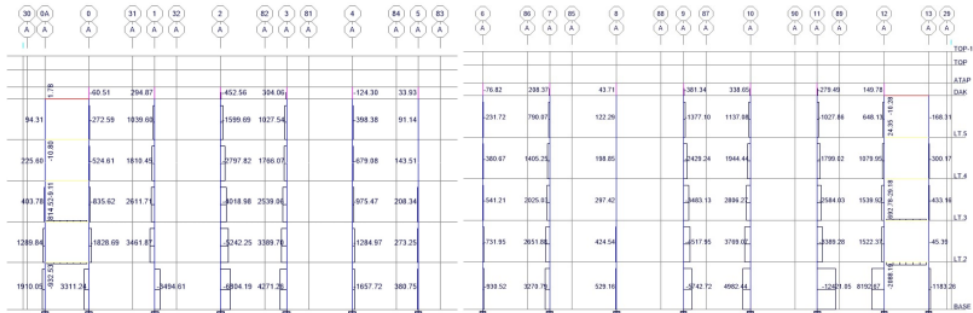
FIGURE 4. Output axial force due to ground displacement

From Fig. 4, it can be seen that vertical movement of ground surface can result in large axial forces in columns. These axial forces have different direction between two adjacent columns. For example, at column 2-A in which ground surface move up 15 cm, there is compression force of 6304.2 kN and at adjacent column (column 3-A) in which ground surface displace down 15 cm, the column has tensile force of 4271.3 kN. On another example, at column 12-A where the ground surface beneath it move down 20 cm, the column has axial compression force of 8192.7 kN and at column 11-A where the ground surface beneath it move up 20 cm, the column has axial tensile force of 12421.1 kN. Meanwhile, based on theoretical formula, the compressive and tensile capacity of reinforced concrete column can be evaluated as follows: compressive capacity =  $0,85 f'c' A_g = 0,85 \times 29,05 (350 \times 500) = 4.321.187 \text{ N} = 4321.2 \text{ kN}$  and tensile capacity =  $0,5 \sqrt{f'c'} A_g = 0,60 \times \sqrt{29,05} (350 \times 500) = 3.050.250 \text{ N} = 404.23 \text{ kN}$ .

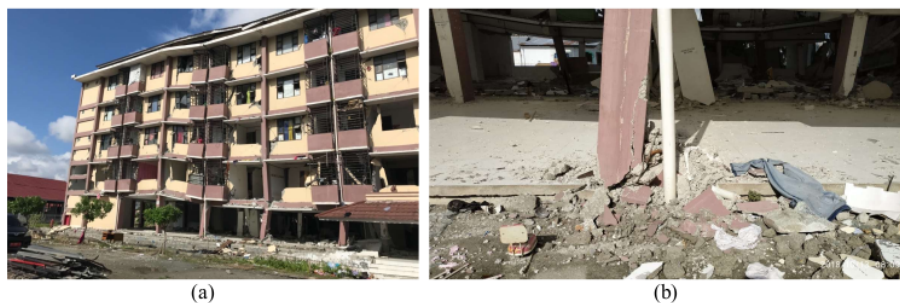
From above discussion, it is clear that both in tension or in compression the axial forces occurred in columns exceed their capacities. As can be seen in Fig. 5.a, column 2-A underwent compression failure. On the other hand, Fig. 5.b shows that column 3-A suffered a combination of tensile and shear failure. Since the tensile capacity of column is much lower than the axial tensile force in column, the column was separated into two parts and then displaced to the side due lateral force as shown in Fig. 5.b. Thus, from data and computer model simulation and considering that the large vertical earthquake load coming earlier than that of horizontal earthquake load, it can explain the damage mechanism taken place on building under investigation.

FIGURE 5. Structural damage: (a) compression failure in column, (b) tensile-shear failure in column

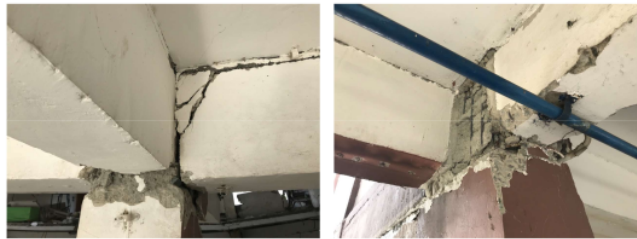
FIGURE 8. Damage of beam-column joint due to earthquake

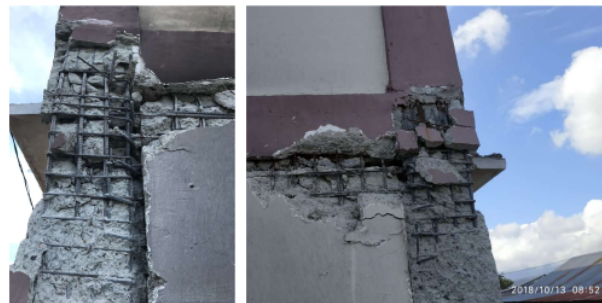
3  
According to Indonesian seismic design code (SNI 03-1726-2002) and concrete building code (SNI 03-2843-2002), moderate moment resisting frame structure can still be used for region medium earthquake risk (zone 3,4,5), without using shear wall. Shear wall in this building is only provided in the first floor to prevent soft story effect. Damage mode of sway mechanism that was employed based on the assumption the earthquake would not occur in this building with the dominant vertical earthquake load. Random column failure in the first-floor results in random failure mode on structure above the first floor. There is no clear damage pattern on every component of the structure. However, if one compares damage evolution from several components with those crack pattern from testing shown in Fig. 7, one can see similarity in pattern. Cracks started from beam and then go into the joint as can be seen in Fig. 8. Stirrups in column and joint were properly installed, but dominant vertical earthquake load led to concrete crushing as shown in Fig. 9.

FIGURE 9. Stirrups installed properly in column, beam and joint, concrete crushing because of tension
