Geotechnical Review of Building Damage and Landslide After Cianjur Earthquake 2022

Civil Engineering Department Universitas Kristen Indonesia (UKI) Jakarta, Indonesia

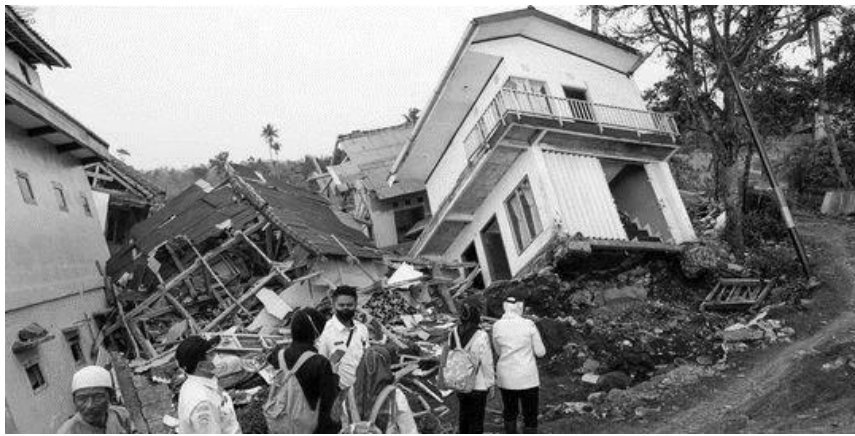
Figure 1. Damage houses due to landslide after Cianjur Earathquake 2022

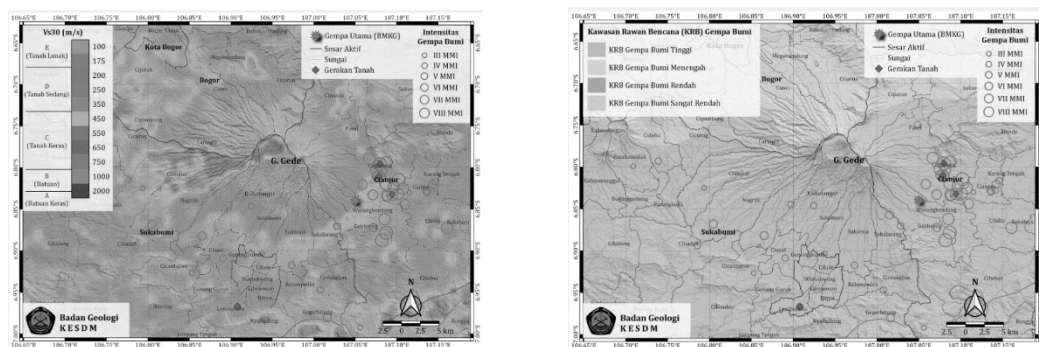
Figure 2. (a) Examines the ground motions that transpired in Cisarua village by analyzing aerial photographs. (b) The present research focuses on the creation of a Surface Rock Hardness Map in the Cianjur Earthquake area, utilizing the Matsuoka Method. - Source (Geology, 2022)

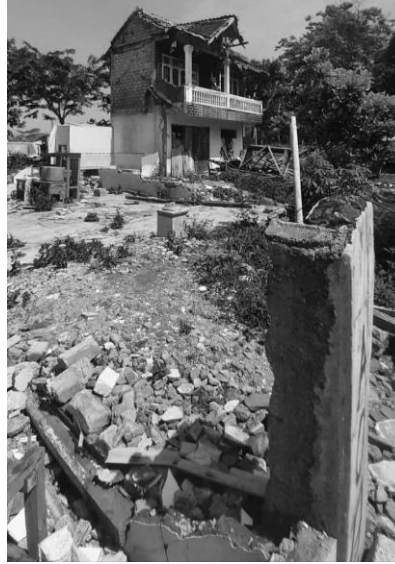
Figure 7. The Red Zone region incurred significant damage, specifically in Sarampad Village
