Geotechnical Review of Building Damage and Landslide After Cianjur Earthquake 2022

Lolom Evalita Hutabarat*, Pinondang Simanjuntak, Efendy Tambunan, & Candra Christianti Purnomo

Civil Engineering Department Universitas Kristen Indonesia (UKI) Jakarta, Indonesia

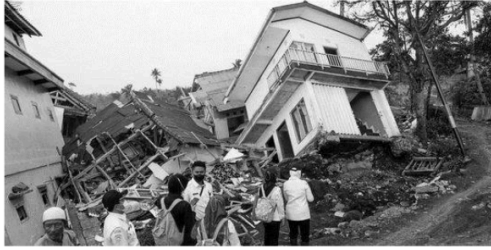
Figure 1. Damage houses due to landslide after Cianjur Earthquake 2022

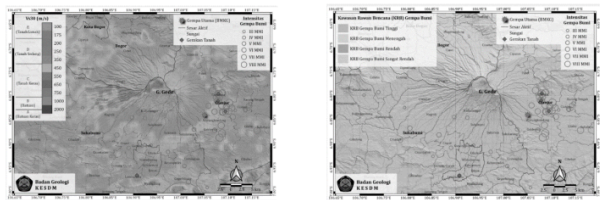
Figure 2. (a) Examines the ground motions that transpired in Cisarua village by analyzing aerial photographs. (b) The present research focuses on the creation of a Surface Rock Hardness Map in the Cianjur Earthquake area, utilizing the Matsuoka Method. - Source (Geology, 2022)
