## Building Assessment Post Earthquake 21 November 2022 in Cianjur District

Sudarno P Tampubolon<sup>1\*</sup>, Agnes Sri Mulyani<sup>2</sup>, Risma M Simanjuntak<sup>3</sup>, Setyadi<sup>4</sup>  
Departemen Teknik Sipil, Fakultas Teknik, Universitas Kristen Indonesia

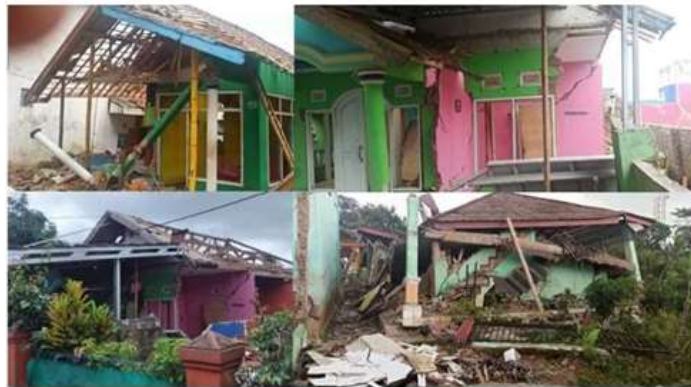
From the assessment conducted by the PKM team from the Civil Engineering Program at FT UKI from December 12 to 17, 2022, several images were obtained showing the damage and collapse patterns of various residential buildings and public facilities in Cianjur. Figure 5 below illustrates the failure that occurred in the column structure due to the column's inability to withstand the applied loads and poor design for supporting axial loads and beams. The image shows that the column can no longer properly support the beams and roof framework.

**Figure 5. Column Structure Failure Unable to Support Beam and Roof Framework**

Column structure failure occurs when columns are unable to withstand loads (especially bending forces), leading to structural failure and column collapse. Therefore, it is crucial to pay attention to the details of stirrup and main bar reinforcement in column design (S. Tampubolon, 2021). Field inspections revealed that the concept of strong column-weak beam design has not yet been implemented, and improper column reinforcement according to standards has resulted in numerous building collapses and failures, (LE et al., 2019), (S. P. Tampubolon et al., 2022; Winarsih, 2010). Figure 11 below shows the column reinforcement details that should be used.

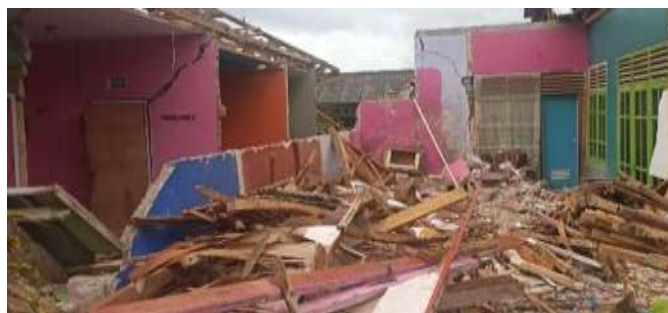
In addition to the column failures, several structural failures in the beams were also identified. Figure 6. below shows the structural failure in the beam due to the inadequate connection between the beam and the column.

**Figure 6. Beam Structure Failure Due to Poor Design for Load Bearing**

Beams are a key structural component of buildings and require careful design and planning. Beam design must adhere to established rules and standards to prevent and anticipate failures (S. P. Tampubolon, 2021a). A proper understanding of good and correct building design principles is essential when designing structural elements. Many field cases reveal discrepancies between the design concept and actual construction, which can lead to critical structural issues. According to SNI 2847-2019, detailed reinforcement must be accurately designed to mitigate shear failures in the structure. Figure 12 below illustrates the detailing of reinforcement in beams and exterior columns.

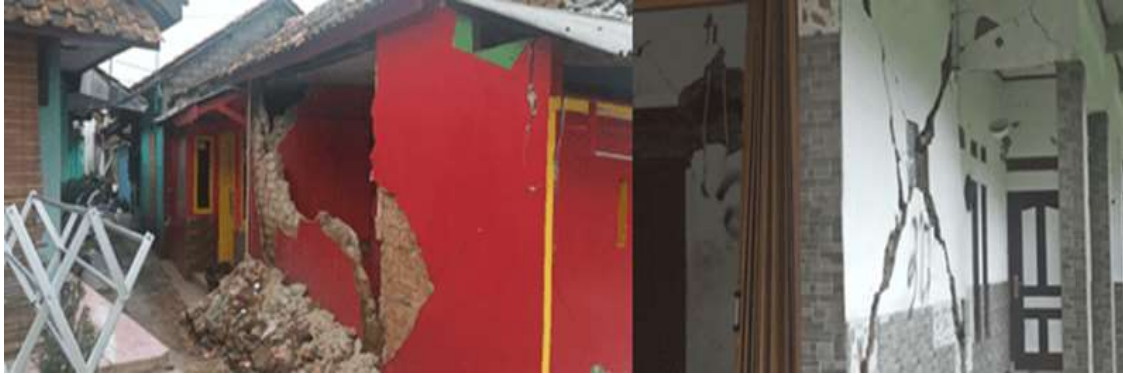
Structural damage was also found in the installation of house walls, where bricks or concrete blocks were not anchored during installation. This can be seen in Figure 7 below, where the house wall collapsed due to the lack of anchors to bind the bricks or concrete blocks used.

**Figure 7. Photo of Wall Collapse Due to Poor Design and Lack of Anchors/Reinforcement in the Columns to Bind the Wall**

To prevent collapse of walls, anchors/ reinforcements should be installed every 6 layers of bricks to secure the bond between the wall and column structure. Figure 13 below shows the details of anchor placement in columns during brick/ block installation.

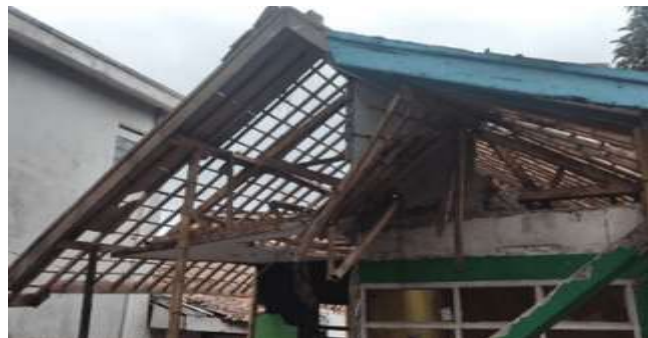
Structural failures were also found in the roof structure. The assessment revealed that the connections in the roof trusses were inadequate, resulting in many roof joint failures, as shown in Figure 8 below.

**Figure 8. Failure of Connections in the Wooden Roof Frame**

To prevent failures in the roof, detailed roof installation must be carried out as shown in Figure 14 below.

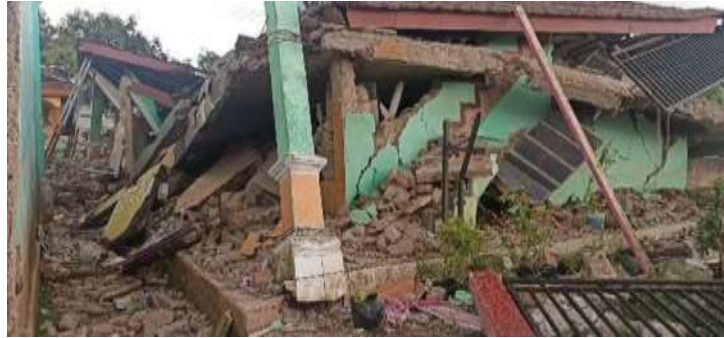
Cianjur Regency is highly susceptible to earthquakes due to the influence of potential faults that cause ground movements. These ground movements are expected to lead to surface fault hazards and collateral hazards such as ground cracks, subsidence, landslides, and even liquefaction. These issues can potentially reduce the bearing capacity of foundations to support loads. Ground movement can also cause foundation shifting or overturning. Foundations are a critical part of the substructure that must be carefully analyzed and installed in the field. Structural failure of the foundation can result in the collapse of the building, causing columns and beams to fail. Post-earthquake inspections in Cianjur revealed that foundation installations lacked attention to detail in joint connections and reinforcement placement, as shown in Figure 9 below.

**Figure 9. Foundation Structure Failure in Supporting Axial and Vertical Loads**

To prevent failures in the foundation, careful attention must be given to the installation of reinforcement and steel anchors used in the foundation. Figure 15 below shows the details of reinforcement installation in the foundation and the anchors used in the footings.

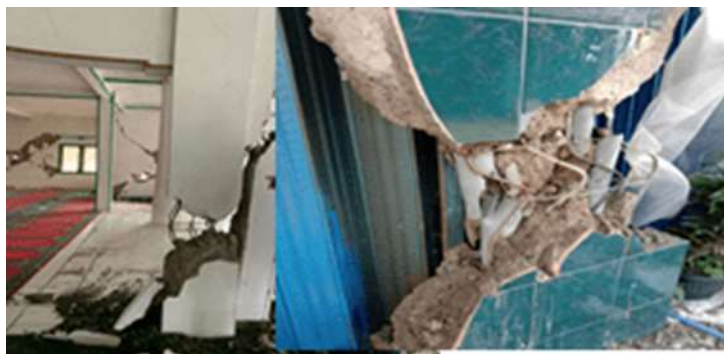
Failures in rebar hooks are commonly encountered in the field due to a lack of understanding of the use of hooks or stirrups in reinforcement. Proper bending details for rebar/ hooks are crucial to anticipate collapse patterns (shear force/ axial force) in beam and column structures (S. P. Tampubolon, 2021b). SNI-2847-2019 specifies standard hook types, including 90° hooks, 180° hooks, stirrup hooks, and tie reinforcement hooks with  $< 135^\circ$ . Figure 10 shows the use of rebar hooks that do not comply with these standards.

**Figure 10. Failure in Rebar Hook Installation in Columns**

Therefore, the installation of rebar hooks must adhere to standards as shown in Figure 16 below (Pujianto et al., 2019; SNI 03-2847-2019, 2019).
