**FORENSIC ANALYSIS OF CULTURAL HERITAGE BUILDING  
MAINTENANCE**

When a building is well maintained, the period of the building's serviceability can exceed 50 years [17], [18]. This study aims to estimate the quality of construction condition of the cultural heritage building GPIB Immanuel Church at Medan Merdeka Timur Street No. 10, Central Jakarta as well as determine the cause and effect of damages in building components. The study also aims to do an economic overview of building maintenance and conservation.

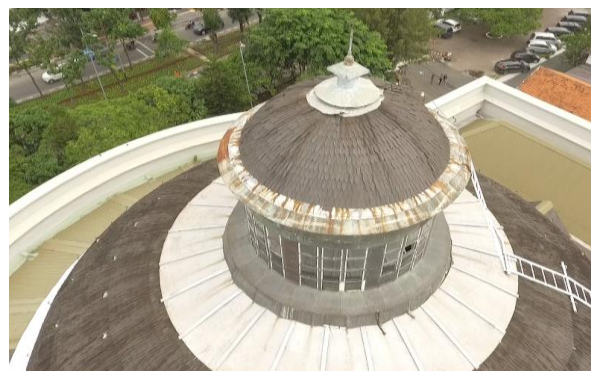
Figure 3. The roof of GPIB Immanuel Church

The GPIB Immanuel Church’s roof is dome-shaped and is covered by wood shingles and zinc (Fig. 3). The quality of the wood shingles covering the dome has decreased and caused seepages. It is caused by rainwater, solar radiation, and air pollution. Also, it is caused by wild plants growing on top of the flat roof and chamfer due to a thick layer of dust and soil pollution. The roof coverings show medium damage while the flat roof and chamfer show minor damage (see Table 4).

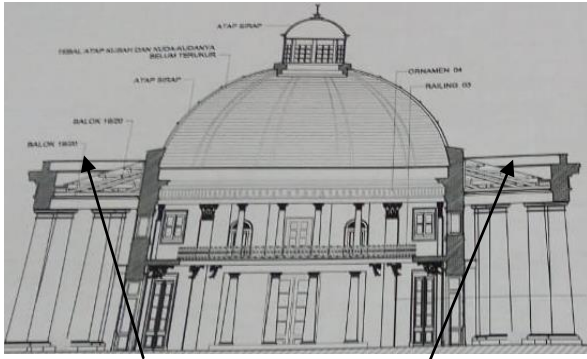
Figure 4. Construction connection on a chamfer

The utility element observed was the Air Conditioner (AC). Damage to utility elements is usually caused by usage and damage to the connection between the chamfer and the pipeline (Fig.4). The damage is moderate.

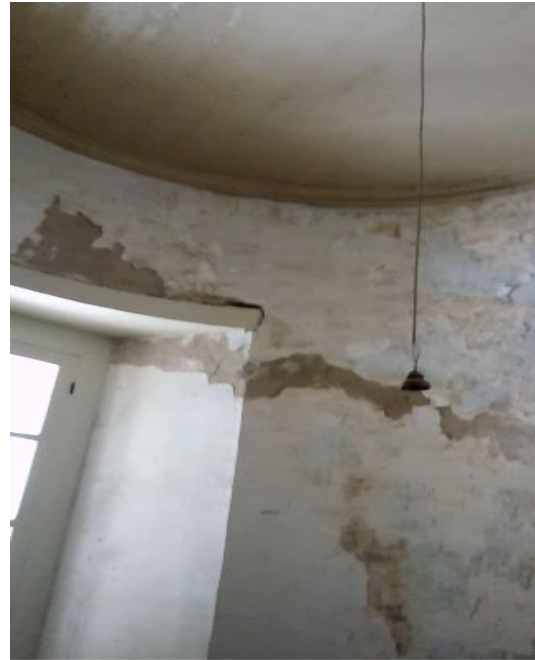
Figure 6. Damage on the inner wall

The inner wall is still in its original shape, and its size and materials remain the same. Even though its treatment is inadequate, the wall's quality and its coating are messy. These problems could be caused by sloppy renovation and rainwater seepage. The damage is minor while its coating is in moderate condition (Fig. 6).

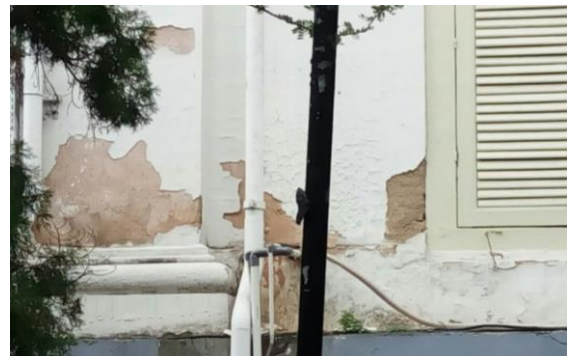
Figure 7. Damage on the outer wall surface

The surface of the outer wall of the GPIB Immanuel Church is white. Even though the wall is clean, its paint is uneven. This unevenness was due to a failure to peel and scrape properly during repainting, which made the paint thick. However, the outer walls' condition is moderate (Fig.7).

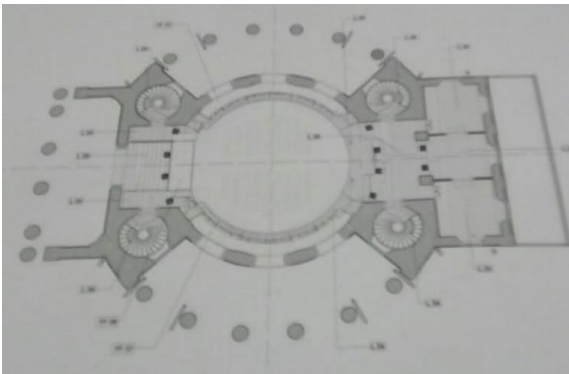
Figure 8. Position of the stairs of GPIB Immanuel Church

The GPIB Immanuel Church has four main stairs in its corners (Fig. 8). Both the stairs outside and inside the building are in poor condition and unsafe.

The wooden second inner staircase next to the front of the podium is heavily damaged. It needs to be repaired immediately since worship activities are routinely carried out on the podium. The staircase inside the church is made of good quality teak, as are the doors and the windows. Since these stairs are always exposed to humidity and are poorly maintained, their life has been decreased. However, the damage is minor.
