FORENSIC ANALYSIS OF CULTURAL HERITAGE BUILDING MAINTENANCE

When a building is well maintained, the period of the building's serviceability can exceed 50 years [17], [18]. This study aims to estimate the quality of construction condition of the cultural heritage building GPIB Immanuel Church at Medan Merdeka Timur Street No. 10, Central Jakarta as well as determine the cause and effect of damages in building components. The study also aims to do an economic overview of building maintenance and conservation.

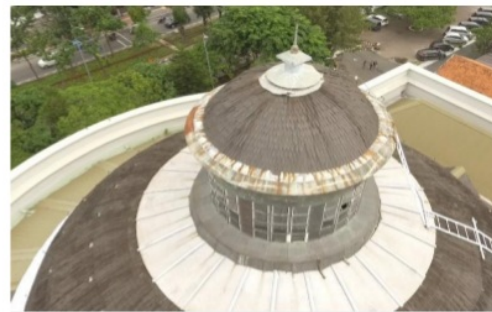
Figure 3. The roof of GPIB Immanuel Church

The GPIB Immanuel Church's roof is dome-shaped and is covered by wood shingles and zinc (Fig. 3). The quality of the wood shingles covering the dome has decreased and caused seepages. It is caused by rainwater, solar radiation, and air pollution. Also, it is caused by wild plants growing on top of the flat roof and chamfer due to a thick layer of dust and soil pollution. The roof coverings show medium damage while the flat roof and chamfer show minor damage (see Table 4).

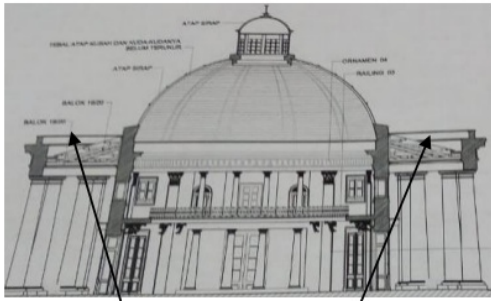
Figure 4. Construction connection on a chamfer

The utility element observed was the Air Conditioner (AC). Damage to utility elements is usually caused by usage and damage to the connection between the chamfer and the pipeline (Fig.4). The damage is moderate.

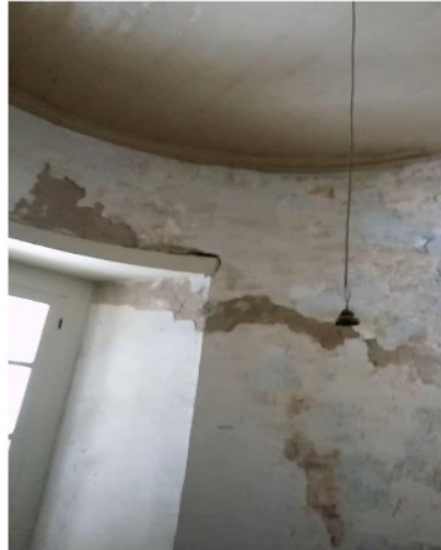
Figure 6. Damage on the inner wall

The inner wall is still in its original shape, and its size and materials remain the same. Even though its treatment is inadequate, the wall's quality and its coating are messy. These problems could be caused by sloppy renovation and rainwater seepage. The damage is minor while its coating is in moderate condition (Fig. 6).

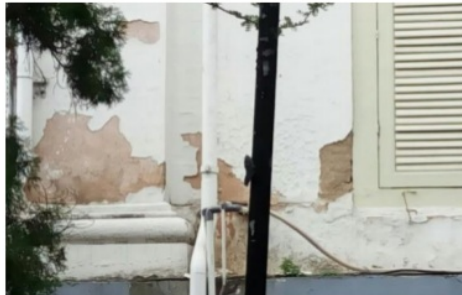
Figure 7. Damage on the outer wall surface

The surface of the outer wall of the GPIB Immanuel Church is white. Even though the wall is clean, its paint is uneven. This unevenness was due to a failure to peel and scrape properly during repainting, which made the paint thick. However, the outer walls' condition is moderate (Fig.7).

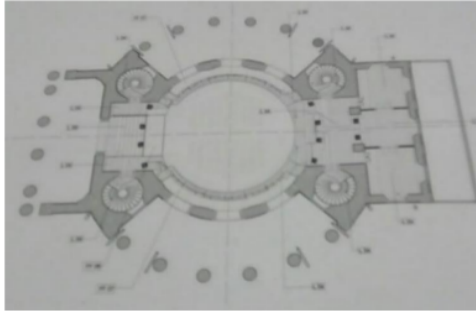
Figure 8. Position of the stairs of GPIB Immanuel Church

The GPIB Immanuel Church has four main stairs in its corners (Fig. 8). Both the stairs outside and inside the building are in poor condition and unsafe.

The wooden second inner staircase next to the front of the podium is heavily damaged. It needs to be repaired immediately since worship activities are routinely carried out on the podium. The staircase inside the church is made of good quality teak, as are the doors and the windows. Since these stairs are always exposed to humidity and are poorly maintained, their life has been decreased. However, the damage is minor.
