**FORENSIC ANALYSIS OF CULTURAL HERITAGE BUILDING
MAINTENANCE**

James Rilatupa^a, Ktut Silvanita Mangani^{b*}^aMagister of Architecture Study Program, Graduate School, Universitas Kristen Indonesia
Jl. Diponegoro No.84-86, Jakarta Pusat, Indonesia, jedrilatupa@gmail.com^bMagister of Management Study Program, Graduate School, Universitas Kristen Indonesia
Jl. Diponegoro No.84-86, Jakarta Pusat, Indonesia, ktut.silvanita@uki.ac.id

When a building is well maintained, the period of the building's serviceability can exceed 50 years [17], [18]. This study aims to estimate the quality of construction condition of the cultural heritage building GPIB Immanuel Church at Medan Merdeka Timur Street No. 10, Central Jakarta as well as determine the cause and effect of damages in building components. The study also aims to do an economic overview of building maintenance and conservation.

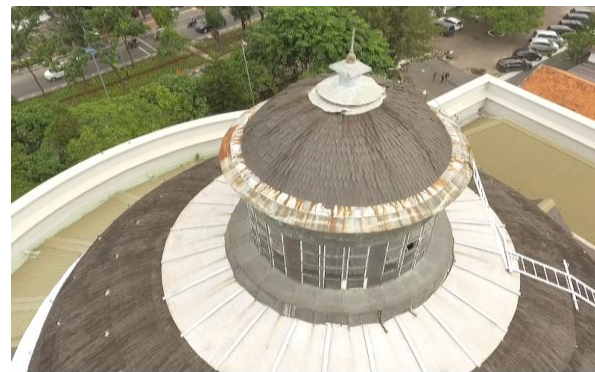
Figure 3. The roof of GPIB Immanuel Church

The GPIB Immanuel Church’s roof is dome-shaped and is covered by wood shingles and zinc (Fig. 3). The quality of the wood shingles covering the dome has decreased and caused seepages. It is caused by rainwater, solar radiation, and air pollution. Also, it is caused by wild plants growing on top of the flat roof and chamfer due to a thick layer of dust and soil pollution. The roof coverings show medium damage while the flat roof and chamfer show minor damage (see Table 4).

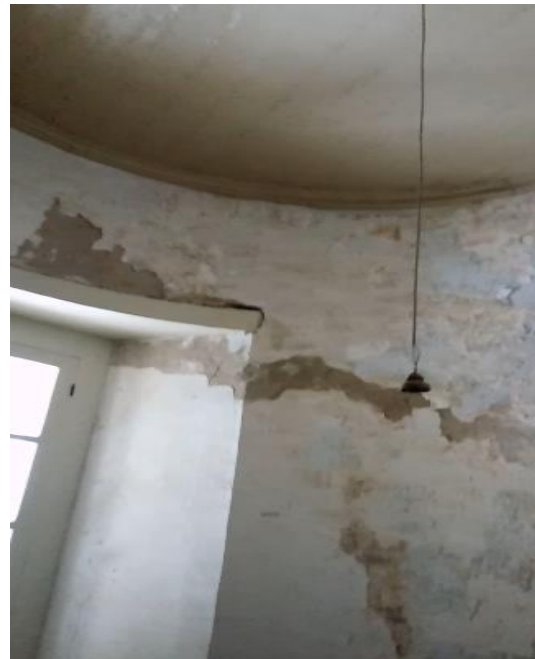
Figure 6. Damage on the inner wall

The inner wall is still in its original shape, and its size and materials remain the same. Even though its treatment is inadequate, the wall's quality and its coating are messy. These problems could be caused by sloppy renovation and rainwater seepage. The damage is minor while its coating is in moderate condition (Fig. 6).

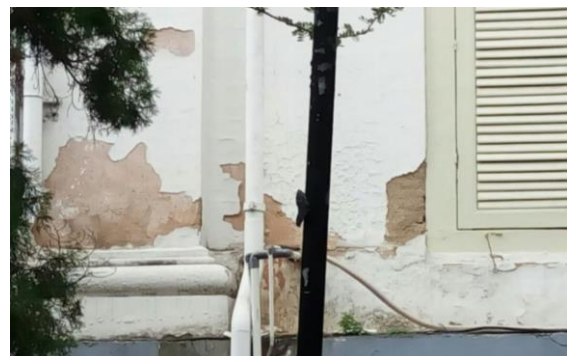
Figure 7. Damage on the outer wall surface

The surface of the outer wall of the GPIB Immanuel Church is white. Even though the wall is clean, its paint is uneven. This unevenness was due to a failure to peel and scrape properly during repainting, which made the paint thick. However, the outer walls' condition is moderate (Fig.7).
