## Evaluation of space comfort based on occupant satisfaction in west Jatinegara flats residential units

Architecture Study Program, Faculty of Engineering, Universitas Kristen Indonesia  
St. Mayjen Sutoyo No.2 Cawang, Jakarta Timur, DKI Jakarta, Indonesia

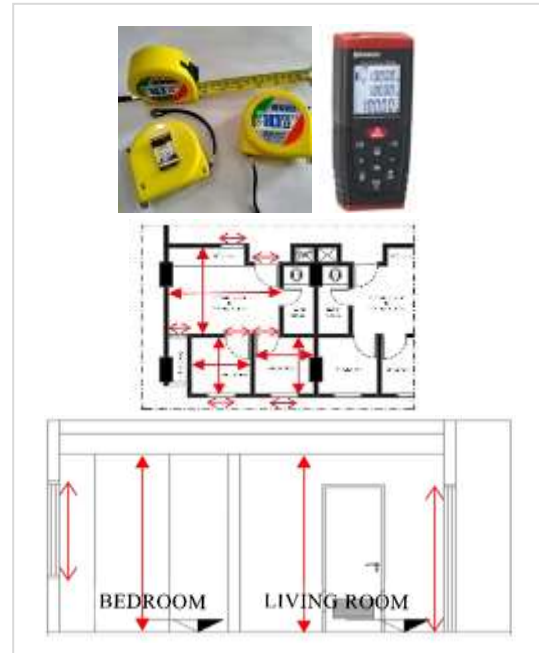
**Figure 1.** Measuring tools, measuring area (plan), measuring area (piece)

Physical measurements of West Jatinegara flats residential units with the aim of describing existing conditions were carried out using a measuring tool that has a measuring limit of 10 meters and a laser meter with the measured area being 2 (two) bedroom areas along with doors, windows and the clear height of the room (ceramic -ceiling), and 1 (one) common room area including the main door, the drying room area door, and the clear height of the room (tile-ceiling). Existing physical measurements in the analysis are used as basic data to determine the comfort of occupant activities.

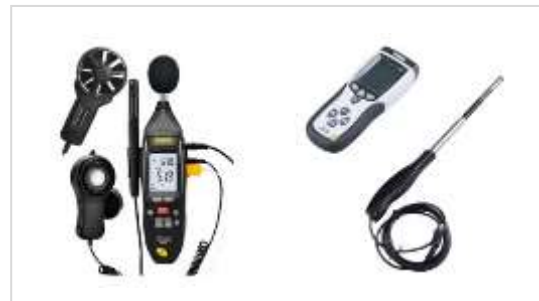
**Figure 2.** Environment Meter and Hot Wire Anemometer

Room thermal measurements are divided into three data, namely temperature, wind speed and humidity. Measurements were carried out at the highest radiation points, namely 2 hours after sunrise (08.00-10.00), mid-day (11.00-13.00), and 2 hours before sunset (15.00-17.00). The tools used in room thermal measurements are a 3 in 1 environment meter (vane anemometer, thermometer and hygrometer) and a hot wire anemometer. Vane anemometers are used to measure wind speed in areas outside the residential unit, while hot wire anemometers are used to measure air movement in areas inside the residential unit. The room thermal measurements in the analysis are used as basic data to determine the body comfort of the occupants.
