## Structural Assessment of Rental Housing Flat Lere in Palu Affected by Palu Earthquake on September 28, 2018

**Abstract.** Rental Housing flat Lere in Palu, Central Sulawesi is one of rental housing flats built by Directorate General Cipta Karya, Department Public Works and Housing in cooperation with local government of Palu during fiscal year of 2010-2011. It is one of buildings damaged by Palu earthquake. To assess the severity of building damage induced by earthquake, building structural engineering experts were conducting engineering investigation. Data from field investigation were used to develop computer model employed in simulating damage mechanism. By running structural model, one can explain damage mechanism in building during the earthquake. From this study, the building is considered severely damage and need to be destroyed. To rebuilt in the area, it is necessary to use structural system that highly resistance against vertical earthquake and to use updated building design codes.

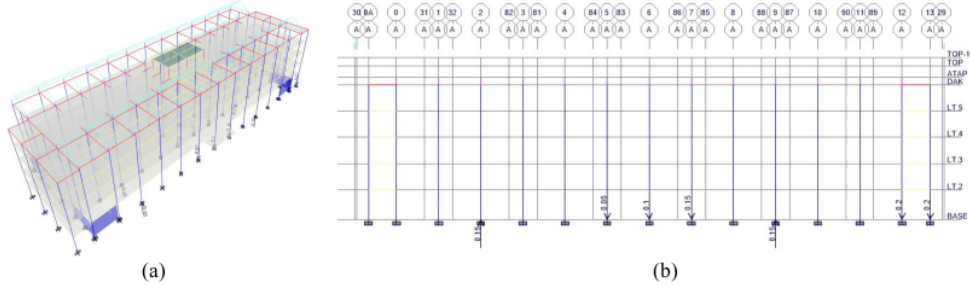
To take into account the effect of vertical earthquake causing damage in building in the form of vertical deformation, the developed structural model includes the vertical deformation at the base (ground displacement) based on deformation observed on the field as shown Fig. 3. The structural model was prepared using structural analysis software ETABS as a tool (computer aided design).

FIGURE 3. ETABS Structural model for rental low-cost housing flat Lere with input ground displacement according to measurements from the field: (a) 3D model building, (b) model section along the length of building

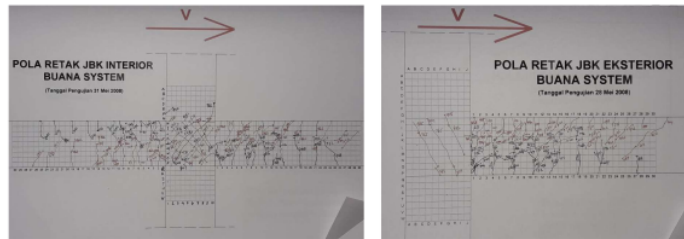
FIGURE 7. Crack pattern at interior and exterior beam-column joints during testing in Laboratory
