## Building Assessment Post Earthquake 21 November 2022 in Cianjur District

Sudarno P Tampubolon<sup>1\*</sup>, Agnes Sri Mulyani<sup>2</sup>, Risma M Simanjuntak<sup>3</sup>, Setyadi<sup>4</sup>  
Departemen Teknik Sipil, Fakultas Teknik, Universitas Kristen Indonesia

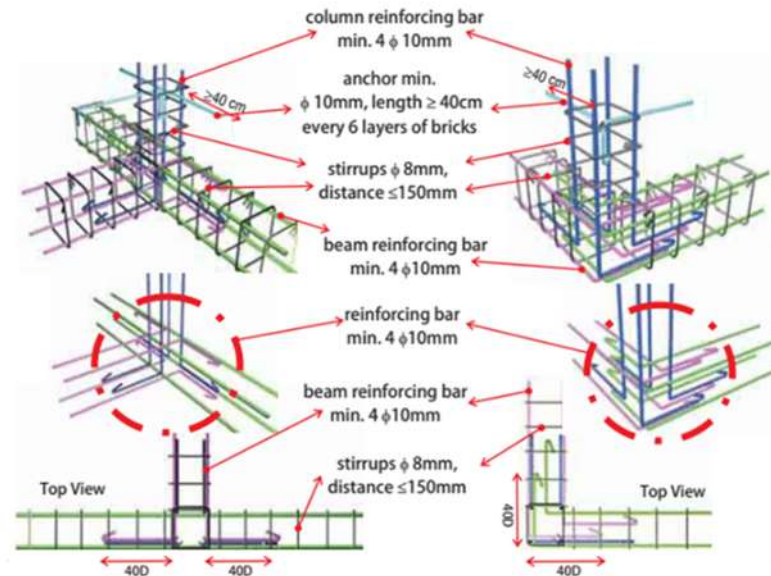
Figure 11. Column Reinforcement Details, (SNI 2847:2019, 2019)

Column structure failure occurs when columns are unable to withstand loads (especially bending forces), leading to structural failure and column collapse. Therefore, it is crucial to pay attention to the details of stirrup and main bar reinforcement in column design (S. Tampubolon, 2021). Field inspections revealed that the concept of strong column-weak beam design has not yet been implemented, and improper column reinforcement according to standards has resulted in numerous building collapses and failures, (LE et al., 2019), (S. P. Tampubolon et al., 2022; Winarsih, 2010). Figure 11 below shows the column reinforcement details that should be used.
