The implementation of the greenship rating is a measuring instrument qualitative the occurrence of a green building that environmental friendly since planning, development, until the operation and daily maintenance. At the stage of building maintenance occurs a decrease in function that is one of the cellulose materials can be measured in detail to find out the causes, symptoms and treatment improvements that need to be given to address them. The research that has been done is aimed at analyzing the condition of illness, greenship rating in quantitative (pathology building) as well as terrotechnology; i.e. see conditions afflicted of wood material infected by termites and economic losses as well as during their useful life due to termite attack. The result showed that the damage that occurs commonly in the apartment and hotel buildings in South Jakarta is the surface of crinkles and cracking hair on cellulose materials, while in college building in East Jakarta damage found were crinkles, the surface of cracked hair and loose/undone. Loss due to termite attacks on this did not damage the structure of the system but only made from cellulose as well as construction of comfort and los

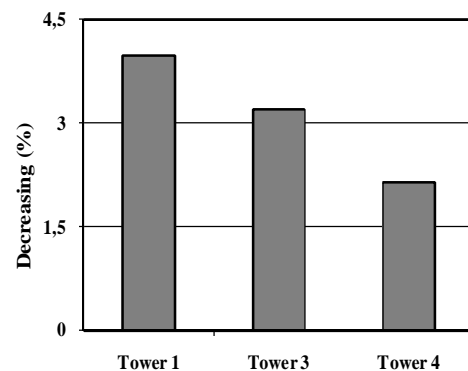
Fig.1. The Decreasing in Wood Materials at Apartment and Hotel in South Jakarta

To calculate the decreasing value of wood component in Tower 1, Tower 3 and Tower 4 buildings; the calculation shall be based on the condition index of building and also wood content in building at least 8

(eight) percent from the overall construction components of building. The calculation results of decreasing value of component based on condition index for Tower 1 was 3.98 percent; Tower 3 was 3.19 percent and Tower 4 was 2.14 percent respectively as seen in Figure 1 above.

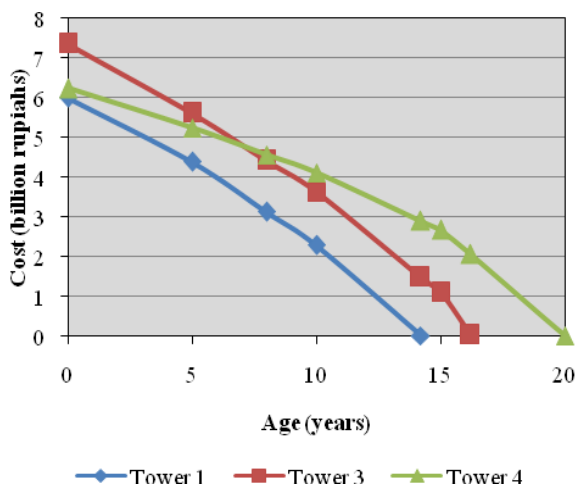
Fig.2. The Decreasing Rate of Wood Materials at Apartment and Hotel in South Jakarta

The research ever done before shows the condition index of building for Tower 1 is 50.22; condition index of building for Tower 3 is 60.10 and for Tower 4 is 73.19. If the rate of decreasing calculated based on condition index of each tower (assuming the condition index will keep until 25 years), and wood components of at least 8 percent from overall building components and also based on decreasing percentage of building every five years [9], therefore the decreasing rate of Tower 1 is faster than Tower 3 and Tower 4 (Figure 2). Loss due to termite attacks on Tower 1, Tower 3 and Tower 4 did not damage the structure of the system but only the construction were made from wood material and loss of comfort and security factors of residence were significantly. The losses calculation caused by termite attacks equivalent with cost of roof cleaning and yard are 2 percent a month, so that same with a decreasing value of a building without maintenance.

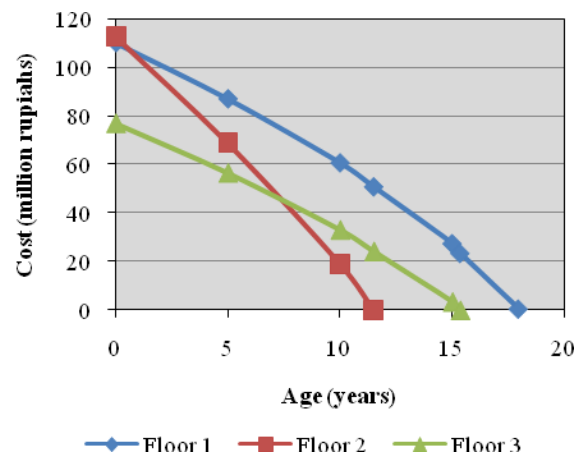
Fig.4. The Decreasing Rate of Wood Materials at College Building in East Jakarta.

Meanwhile, the result of previous study obtained an index condition for this three storey building is 77.36, consisting of: index conditions on the 1st floor with a value of 83.18; the 2nd floor at a value of 68.82 and the 3rd floor with a value of 78.67. To calculate the value of the decreasing of wood material components at building, then these calculations based on an condition index of floor as well as the content of wood material is 4 percent of the overall construction component of this building (based on construction cost). The results showed a calculation of rate decrease in wood materials components are calculated based on condition index each floor (assuming the condition index will keep until 25 years) and based on the decreasing percentage of building every five years [9]; the decreasing rate of wood material components on the 2nd floor is faster compared to the 1st floor and 3rd floor (Figure 4).
