# Evaluation of Space Comfort based on Occupant Satisfaction in West Jatinegara Flats Residential Units

Ulinata<sup>1</sup>, Sally Septania Napitupulu<sup>2</sup>, Adinda Garda Merah<sup>3</sup>, Kristoforus Dandy<sup>4</sup>

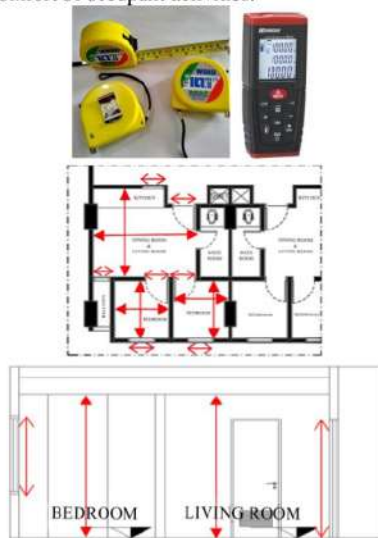
Physical measurements of West Jatinegara flats residential units with the aim of describing existing conditions were carried out using a measuring tool that has a measuring limit of 10 meters and a laser meter with the measured area being 2 (two) bedroom areas along with doors, windows and the clear height of the room (ceramic -ceiling), and 1 (one) common room area including the main door, the drying room area door, and the clear height of the room (tile-ceiling). Existing physical measurements in the analysis are used as basic data to determine the comfort of occupant activities.

Figure 1. Measuring tools, measuring area (plan), measuring area (piece)

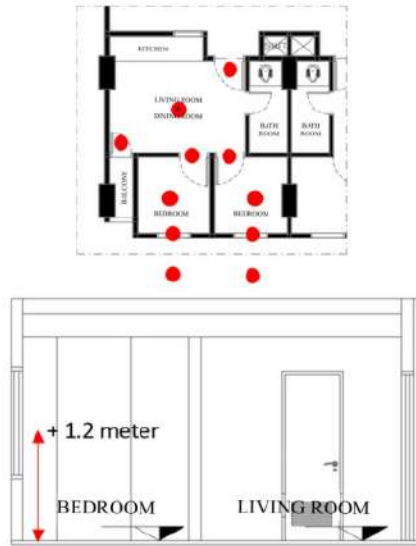
The thermal measurement points are located in the bedroom area (two rooms), the common room including the kitchen (1 room), and the drying room area. In the bedroom area, the measurement points are at the window sill area, the living room area of the bedroom, and the bedroom doorway area; in the common room and kitchen area, the measurement points are in the main doorway area, the middle area of the common room, and the drying room doorway area; and the measurement points for the drying room area are located at the threshold area of the drying room fence and the middle area of the drying room. The measuring point for the indoor area is at an elevation of + 1.2 meters starting from the ceramic area.

Figure 3. Position of measuring point (plan) and height position of measuring point (section)

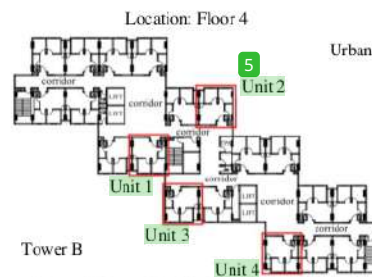
Figure 1. Plan of the 4th floor in Tower A where a Temperature, Humidity and Wind Speed Measurement Survey was carried out (Source: Author, 2022)

The residential units where temperature, humidity and wind speed measurement surveys were carried out were units on the **8**, 10th and 15th floors. On the 4th floor, temperature, humidity and wind speed measurement surveys were carried out on units marked with red boxes as seen in the image below

In unit 1, a temperature, humidity and wind speed measurement survey was carried out in 2 periods, namely in March and September, where in March it was carried out from morning to evening with normal wind speed so that the windows in both bedrooms could be opened optimally. The results of temperature measurements from morning to evening were above normal. The humidity measurement results are still in the normal/ideal category.

In unit 2, a temperature, humidity and wind speed measurement survey was carried out in 2 periods, namely in March and September, where in September the survey was carried out in the morning until the evening with higher wind speeds than in March, causing there to be windows in the rooms, broken sleep. The results of temperature measurements from morning to evening were above normal. The humidity measurement results are still in the normal/ideal category.

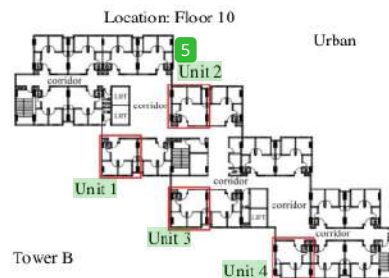
The temperature, humidity and wind speed measurement survey continued on the 10th floor of tower A, in the unit marked with a red box as in the picture below:

**Figure 2. Plan of floor 10 in Tower A where a temperature, humidity and wind speed measurement survey was carried out (Source: Author, 2022)**

In unit 1, a temperature, humidity and wind speed measurement survey was carried out in 2 periods, namely in March and September, where in September it was carried out in the morning until the evening with higher wind speeds than in March, causing part of the bedroom window to be damaged. The results of temperature measurements from morning to evening were above normal. The results of humidity measurements in March started to feel damp but in September it became normal/ideal again.

In unit 2, a temperature, humidity and wind speed measurement survey was carried out in 2 periods, namely in March and September, which was carried out in the morning until the evening with normal wind speed and the windows were in good condition or functioning and nothing was damaged. The results of temperature measurements from morning to evening were above normal. The results of humidity measurements in March started to feel damp but in September it became normal/ideal again.

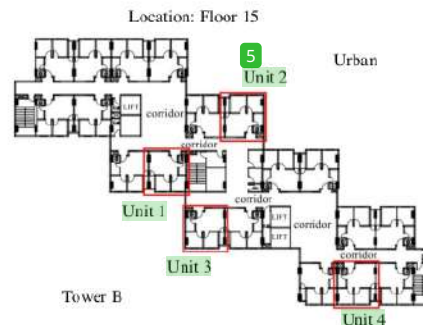
on the 15th floor of tower A, in the unit marked with a red box as in the picture below:

**Figure 3. Plan of floor 15 in Tower A where a temperature, humidity and wind speed measurement survey was carried out (Source: Author, 2022)**

In unit 1, a temperature, humidity and wind speed measurement survey was carried out in 2 periods, namely in March and September, where in September it was carried out in the morning until the evening with normal wind speed and the windows were in good condition or functioning and nothing was damaged. . The results of temperature measurements from morning to evening were above normal. The results of humidity measurements in March started to feel damp but in September it became normal/ideal again.

In unit 2, a temperature, humidity and wind speed measurement survey was carried out in 2 periods, namely in March and September, where in September it was carried out in the morning until the evening with normal wind

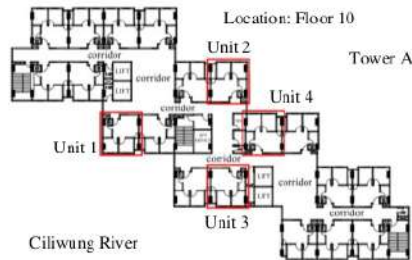
The temperature, humidity and wind velocity measurement survey was then continued on the 10th floor in tower B, in the unit marked with a red box as in the picture below:

Figure 5. Plan of floor 10 in Tower B where a temperature, humidity and wind speed measurement survey was carried out  
(Source: Author, 2022)

2 periods, namely in March and September, where in September it was carried out in the morning until the evening with normal wind velocity so that it could be opened optimally. The results of temperature measurements from morning to evening were above normal. The results of humidity measurements in March felt damp, but in September it became normal/ideal again.

out in 2 periods, namely in March and September, where in September it was carried out in the morning until the evening with high wind velocity, resulting in damaged windows. The results of temperature measurements from morning to evening were above normal. The results of humidity measurements in March felt damp, but in September it became normal/ideal again.

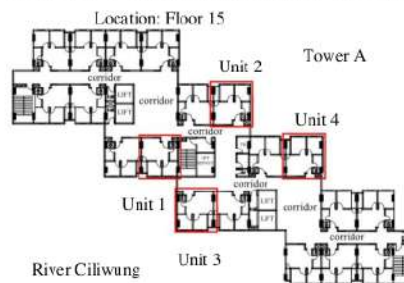
The temperature, humidity and wind velocity measurement survey was then continued on the 15th floor in tower B, in the unit marked with a red box as in the picture below:

Figure 6. Plan of floor 15 in Tower B where a temperature, humidity and wind speed measurement survey was carried out  
(Source: Author, 2022)

velocity measurement survey was carried out in 2 periods, namely in March and September, where in September it was carried out in the morning until the evening with normal wind velocity so that it could be opened optimally.

The results of temperature measurements from morning to evening were above normal. The results of humidity measurements in March and September were normal/ideal.

In unit 2, a temperature, humidity and wind velocity measurement survey was carried out in 2 periods, namely in March and September, where in September it was carried out in the morning until the evening with normal wind velocity so that it could be opened optimally. The results of temperature measurements from morning to evening were above normal. The results of humidity measurements in March and September were normal/ideal.
