The Beauty of Toba Architecture Living in harmony with the surrounding natural environment

M. Maria Sudarwani^{1*}, Galuh Widati¹, Situmorang L.Bintang², Faran Sere²

¹lecturer of Architecture Study Program, Universitas Kristen Indonesia

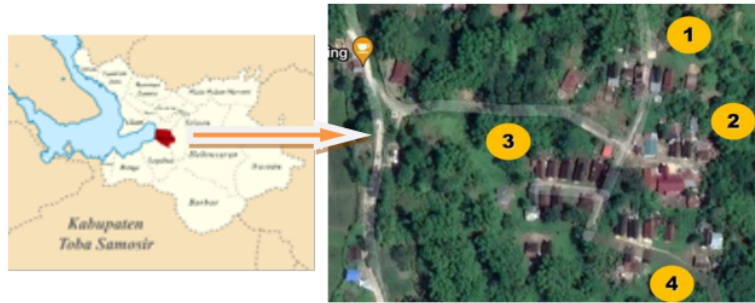
Figure 1. Map of Sigumpar Area
(Source: Wikipedia, 2022; Google Maps, 2022)

The settlement layout of the Toba villages follows a pattern of two facing each other, axis to the north and south, and forms a village called *lumban* or *huta*. The village has two gates (*bahal*) on the north and south sides. In this study, the research area is divided in 4 observation units which are divided based on the characteristics difference of each *huta*. The interesting thing about the fourth observation *huta* in Sigumpar is the difference in the direction of the site's orientation between *jabu/ruma* and *sopo* houses. In Observation *huta* 1, seven unit houses are facing the north side which four houses are still in Toba Architecture (*Jabu*) while three other houses are modern, and also there is one *sopo* facing the south side of the site (See Figure 1).

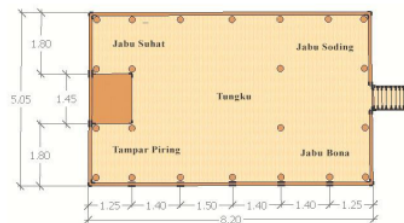
Figure 6. The Floor Plan of Jabu in Sigumpar
(Source: Personal Documentation, 2021)

Jabu House, or *Bolon* House, has a rectangular building shape that is the type of stilt house. The floor height reaches 1.75 m above the ground, and the bottom is used as an animal cage. As for the various rooms as follows: a) *Jabu bona*: This section is occupied by the host family; b) *Jabu Soding*: This section is for the family of the host's daughter; c) *Jabu suhat*: This section is used for the oldest married boy; and d) *Jabu Tampar Piring*: Reserved for guests and phobias related to drinking and other food needs (Nurmala, 2012). See Figure 6. In addition there are two more partition spaces, *Jabu tonga-tonga ni jabu bona* is the area between *jabu bona* and *jabu tampar piring* and *Jabu tonga-tonga ni jabu soding* is between *jabu soding* and *jabu suhat*. Basically, the Toba house has three important parts, known as the three cosmos chambers (*banua na tolu*) with their respective functions and philosophies. The three main parts are a) *Banua Ginjang*, is a world where the gods live consisting of seven levels of the sky, with the highest level as the place of *Ompu Mulajadi Na Bolon*; b) *Banua Tonga*, which is the middle part that is likened to the earth where humans move. This part of the house is in the form of a large room without a sealing wall; and c) *Banua Toru*, is the bottom of the place of King *Padoha / Begu*, namely the world of subtle beings. See Figure 7. In the traditional *batak toba* house this section is likened to a cage that serves as a cattle pen.

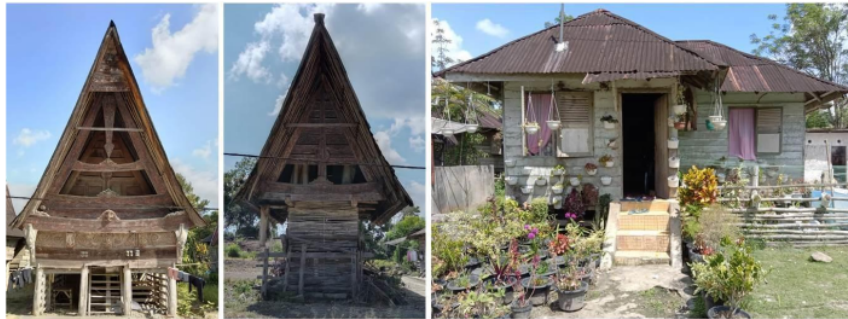
Figure 8. The Building Typology of Sigumpar (*Jabu; Sopo; Ruma Eper*)
(Source: Personal Documentation, 2021)

The typology of traditional buildings in the Sigumpar area is based on the shape of the Toba house, including: *Ruma* (Dwelling House) and *Sopo* (Rice Barn) typology. *Ruma* and *Sopo* are separated by a large courtyard that functions as a common space for the *Huta* residents. *Ruma* is usually occupied at night until the morning, while *sopo* is usually for activities from afternoon to evening. *Sopo* (Rice Barn) is used as a storage area or barn that contains rice that has been harvested. Another typology of dwellings is *Ruma Eper* (of wood). See Figure 8.

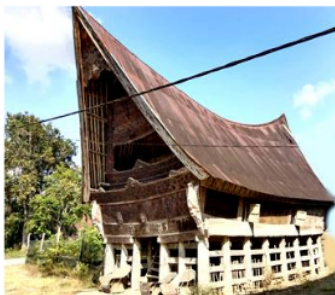
Figure 9. The Beauty of Jabu in Sigumpar
(Source: Personal Documentation, 2021)

The beauty of Sigumpar architectural house (*Ruma*) lies in the sharp roof on the front and back. The front is made longer and higher than the back, with the belief that it will pray for the descendants of the owner of the house to be more successful than the current one (Siahaan, 2019). See Figure 9 and 10. The description below is the elements of Toba architectural house:

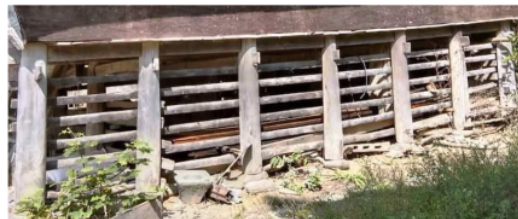
Figure 11. The Poles of Sigumpar House
(Source: Personal Documentation, 2021)

Sigumpar housing structure used the frame of wood. The housing wall's function is non-bearing, just as a partition made of wood, with the umpak. Sigumpar houses are characterized by *panggung* houses with the *umpak* foundation (the foundation made of a single stone) and wood columns. The foundation of the Toba house uses a ring foundation type, where the stone is the foundation of the wooden column that stands on it. Poles of the house have a diameter of 42 - 50 cm, standing on a rock with a flexible structure so that it is resistant to earthquakes. There are 18 poles that contain the philosophy of togetherness and sturdiness. The reason for using a pedestal foundation is that there were still a large number of ojahan stones and logs at that time. And no adhesive tools such as cement have yet been found. The distance between the poles is 90-100 cm. The shape is round. The poles are only on the sides so as to create an empty space in the middle. The empty space is used as a place for livestock.

The main poles of the *sopo* are laid on a large slate stone 40 cm (16 inches) in diameter and taper down, 20 cm (7.9 inches) in diameter. The main poles are supported by small poles (supporting poles). All posts are bounded by rail anchors arranged in four narrow tiers. Each anchor level is named (from bottom to top): stimulation beam, *galapang* beam, *sumban* and *gulang-gulang*. Unlike the *sopo*, the traditional house has three layers of anchors instead of four. The difference between the Toba architecture house (*ruma*) and the *sopo* lies in the space system and the shape of the poles. The main poles of the *Jabu* house are built like a tree that shrinks from the bottom up. The opposite is seen in the *sopo*, the main poles are enlarged upwards. The walls of the Toba architecture house are made wider at the top, with the aim that people in the house can easily see down and towards the road. The bigger *sopo* has a fence made of wooden planks, while the simple *sopo* has no fence. Toba house building is a type of stilt house building, which is a house that is supported by poles that are the main structure of the building and also to withstand the burden of the floor that is above the pole and also the roof construction load (Balai Litbang Perumahan Wilayah I Medan, 2019).

Toba house building is a type of stilt house building, which support by poles that are the main structure of the building and also to withstand the burden of the floor that is above the pole. The structure of poles and pedestals creates adaptive buildings against earthquakes and land contours. All the building poles rest on loose pedestals so that during an earthquake, they can move but not damage the construction. Another reason, with loose foundations, architecture does not damage the ecological balance of the earth, and at the same time, does not allow the earth to be damaged by planting foundation stones (Josef, 1998). *Umpak* also prevents the rotten wood poles exposed soil moisture and soil insect attack. See Figure 11.

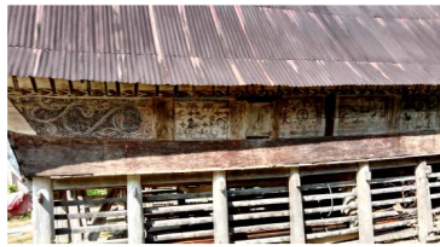
Figure 12. The carved and coloured Wall of Sigumpar House
(Source: Personal Documentation, 2021)

Like the function of walls in general, the walls of batak houses serve as space dividers. This wall is made of *Simartolu* wood. Walls that bind to each other with peg joints or by being tied (Balai Litbang Perumahan Wilayah I Medan, 2019). The floor is made of wooden planks that are installed parallel to the direction of the entrance to the house. The wall of *jabu*, when seen from the looks of it, forms a trapezoid with the wall position not upright but tilted. Because the main structure is wood, the walls are more of a filler that serves to cover the outside of the house, separating the inside and outside of the house.

The lowest part, which is slanted and decorated in a very complex way, is located on the roof of the front wall. Here there is a *dorpi* which is also decorated. Above the *dorpi* there is a *Tombonan* (the middle is sticking up). It is a triangle that is hollowed out in the middle and complexly scored once erected vertically. The Toba house's walls are slanted so the wind can easily enter. The slanted wall ties, called ret-ret ropes, are made of palm fiber or rattan. This strap forms a pattern like a lizard with 2 heads opposite each other, meaning that the lizard is depicted as a house guard, and the 2 heads are opposite each other, symbolizing that all house residents have the same role and respect each other. All exterior walls can be carved and colored. See Figure 12.

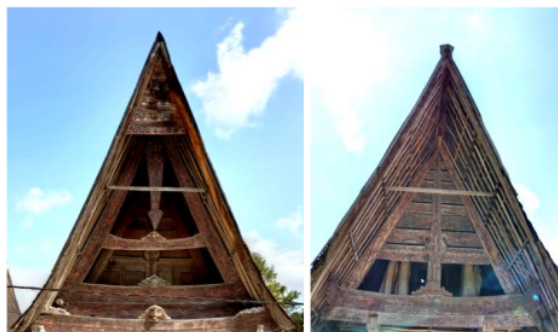
Figure 13. The Sopi-sopi Ornaments of Sigumpar House
(Source: Personal Documentation, 2021)

The roof of *Ruma/jabu* takes the basic idea of a buffalo's back. Its curved shape adds to its aerodynamic value against strong lake winds. The roof is made of *ijuk*, an organic material easily available in the local area. The Toba Samosir people consider the roof as something sacred, so it is used to store their heirlooms. The type of construction and the roof used to be very genial in solving site characteristics and local climate. On the roof, roof beams serve as a fulcrum of the building's roof construction. The roof construction is propped up on beams and then reinforced and held by rattan ropes and *ijuk* ropes (Balai Litbang Perumahan Wilayah I Medan, 2019). The roof of the Toba house is a separate structure that is erected on the floor/base; the roof retaining poles are not continuous from the ground. *Sopi-sopi* of the roof is rich with decorations and carvings both with paint and without the paint (See Figure 13). *Sopi-sopi* is a structure above the wall that serves to support the roof.

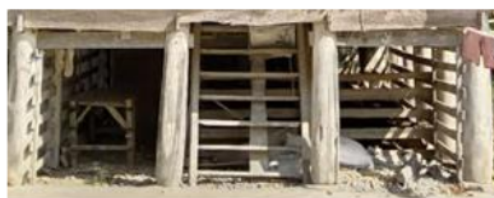
Figure 14. The Stairs of Sigumpar House
(Source: Personal Documentation, 2021)

There are odd numbers of stairs in *Jabu* House. It is based on the people's belief that odd numbers are lucky numbers. The number of stairs has an odd rule usually amounted to 5 or 7 stairs. This is because of the belief that the number of odd rungs means luck (Balai Litbang Perumahan Wilayah I Medan, 2019). See Figure 14. The Main Door juts in with a width of 80 cm and a height of 1.5 m, surrounded by carvings, paintings and writings, and two lion heads on the doorway.

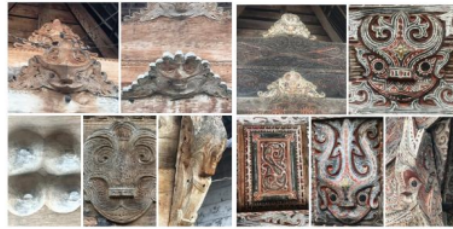
Figure 15. The Ornament and the Colour of Gorga
(Source: Personal Documentation, 2019)

Based on how it is done, the Toba *gorga* consists of two types: *gorga* carving (chiseled *gorga*) and *gorga dais* (painted *gorga*). *Ruma* with many ornaments (*gorga*) carved and painted, is called *Ruma Gorga Sarimunggu* or *Jabu Batara Guru*. At the same time, the Toba house that is not carved and without paint is called *Jabu Ereng* or *Jabu Batara Siang* (Soeroto, 2003). Based on the shape of the ornament, *gorga* has many types. Important carving symbols are lizards, snakes, or buffalo, which have certain meanings. *Gorga* lizard means survival and a solid and unbroken sense of brotherhood. At the same time, the shape of the snake ornament is associated with the belief that a house entered by a snake signifies that its inhabitants will get abundant blessings. *Gorga* and the shape of the buffalo's head have the meaning of gratitude for the hard work of the buffalo, which has helped humans in working in agricultural fields. The types of *Gorga* Toba include: *Gorga Ipon-Ipon*, *Gorga Desa Naualu*, *Gorga Ogung: Ogung*, *Gorga Sitompi*, *Gorga Simataniari*, *Gorga Singa-singa*, *Gorga Jorgom*, *Gorga Boraspati dan adop-adop*, *Gorga Gaja Dompok*, *Gorga Dalihan Natolu*, *Gorga Simeoleol*, *Gorga Sitagan*, *Gorga Sijonggi*, *Gorga Silintong*, *Gorga Iran-iran*, *Gorga Hariara Sundung di Langit*, *Gorga Hoda-Hoda*, *Gorga Ulu Paung*. See Figure 15.

Carved house ornaments can be found from the outside to the inside of the Toba architecture house. Many typical Toba Samosir carvings can be found in the house, which have a meaning as a repellent to reinforcements (danger, disease, and others). This ornament is often called *Gorga*. The colors of the carvings are generally red, white, and black. Except for the house's poles, roof and floor, all exterior walls can be carved and colored. According to various sources, the color is taken from natural materials. Thus, the color itself was created from materials provided by nature. The ancestors of the Toba Samosir people created the color in the following way: a) Red paint is taken from hula stone, a kind of red natural stone that cannot be found in all areas. This stone is ground into a fine powder like flour and mixed with a bit of water, then smeared on the carvings; b) White paint is taken from white soil, fine and soft soil, and ground until smooth and mixed with a little water; and c) Black paint is made from a type of plant that is ground

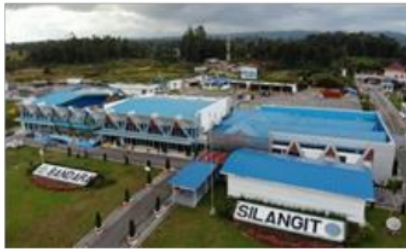
Figure 16. Silangit Airport Images
(Source: Kompasiana, 2021))

In Figures 16-19 below are the examples of post-modern Indonesian architectural works that have aspects that are still based on Toba architecture, especially on sensitivity to nature (local wisdom), namely: Silangit Airport design in North Sumatra, Church of HKBP Sudirman Jakarta, Church of HKPB Tebet, Jakarta, and the Catholic Church of St. Mikael Pengurusan, Samosir which all carries the theme of Toba architecture.

Today's architects should equip themselves with knowledge of Indonesian vernacular architecture to have sufficient basic knowledge to maintain its sustainability of it in the post-modern architectural era. The concept of application of Toba architectural design can be seen in the Silangit Airport design in North Sumatra. See Figure 16. Silangit Airport is located at Jalan Silangit, Silando Muara, Silando Siborong-borong, North Tapanuli Regency, North Sumatra 22476. The airport has a runway size of 2,650 m x 45 m. The airport adopted the Toba Architecture implemented on several sides of the building. The table below is the application of the concept of Toba Architecture at Silangit Airport.
